A PASSIVE MEANS TO DETECT HOT TROLLEY INSULATORS

**M. R. Yenchek
A. J. Hudson**

**NIOSH
Pittsburgh, PA**

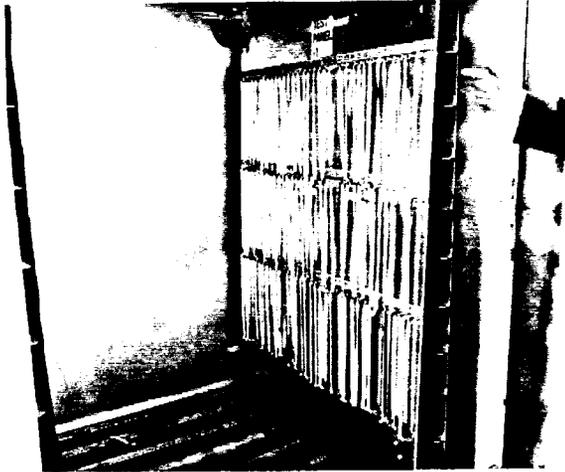
Additional tests were planned to gauge the reliability of the design. One hundred wax-sealed cartridges were constructed and mounted on a 1-m by 1.5-m aluminum panel (Figure 6). This panel was inserted into a 2.7-cu m air oven and the temperature in the oven was gradually increased from ambient at the rate of 25 °C per hr. Ninety-seven of the cartridges successfully ejected the Teflon streamer within ± 5 °C of the target temperature of the wax. An examination of the three that failed to activate revealed deformities in the brass cartridges that hindered spool ejection. Careful packaging and handling of the device should preclude this damage in storage and transit.

Figure 6. Fired cartridge following test in air oven.
